USARPAC Transoceanic Test

Why Use a VCI Fitted Cover?

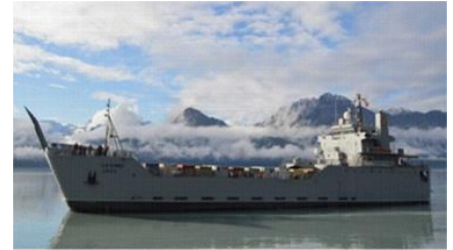
U.S. Army vessel CW3 Harold C. Clinger Logistics Support Vessel (LSV-2)
