Florida National Guard Test Why Use A VCI Fitted Cover?

In 2013, at the request of the Florida National Guard, a Satellite Transportable Terminal (STT) was protected by a Transshield XT advanced protective cover with Vapor Corrosion Inhibitor (VCI) at a Florida National Guard base in Jacksonville, FL. Paired coupons were employed inside and outside the cover to assess the level of protection provided to the asset. Some stand-alone coupons were also employed.

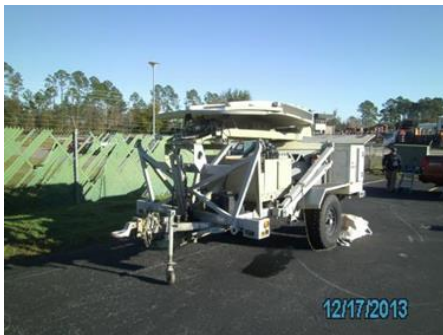
Satellite Transportable Terminal (STT)

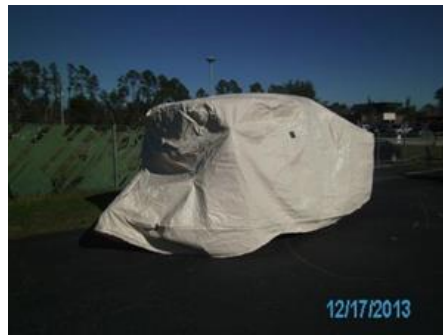
STT protected with a Transshield XT cover

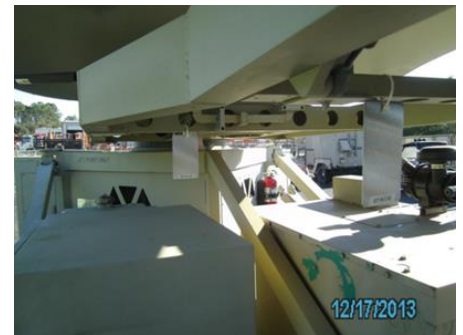
Test coupon placement in the open space at the center of the STT

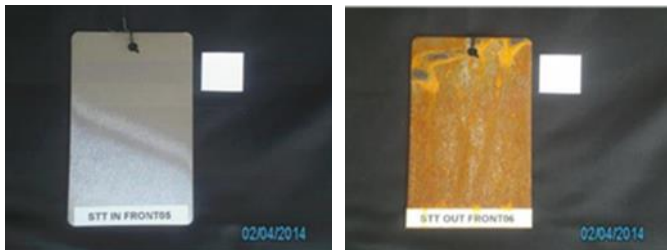
Typical paired coupon post trial results highlight the dramatic corrosion prevention and are shown below.

Transshield XT 99.9% Protection Outside Cover 12.3% Protection

In this test, the Transshield XT advanced protective cover provided in excess of 99% protection for all coupons. A logical conclusion is that similar protection is provided to unpainted metals of the STT.
