Why Use A VCI Fitted Cover? U.S. Army Reserve Test

In 2017, at the request of the United States Army Reserve G-4, a MEP-803A generator and a HMMWV-1097R1 were each protected by a Transshield XT advanced protective cover with vapor corrosion inhibitors (VCI) at an Army Reserve base in Orlando, FL. Paired coupons were employed inside and outside the cover to assess the level of protection provided to the asset. Some stand-alone coupons were also employed.

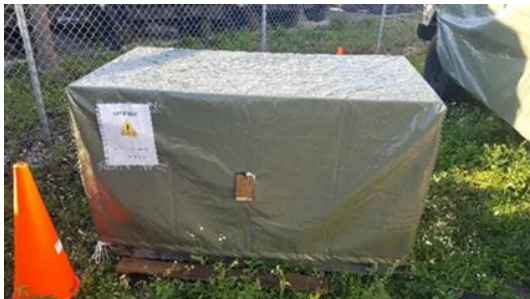
MEP-803A generator protected by an XT cover

At the conclusion of the 47-day field trial, U.S. Army Reserve personnel witnessed the removal of the Transshield XT covers. Photographs of the coupons were immediately taken to record the levels of corrosion. Protection provided by the cover is quantified by calculating the area of the coupon not corroded and expressing that as a percent of the total coupon area. Photographs of the covered MEP-803A generator and a covered HMMWV-1097R1 are shown below.

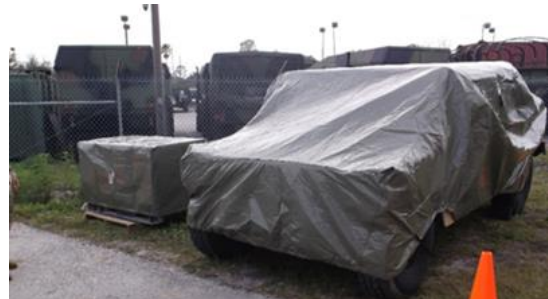
HMMWV-1097R1 protected by an XT cover
